1. REPORT NUMBER VA 03317	2. GOVT ACCESSION NO. AD-A091	3. RECIPIENT'S CATALOG NUMBER 538
4. TITLE (and Subtitle) Phase I Inspection Report National Dam Safety Program Broadus Dam Caroline County, Commonwealth of Virginia		5. TYPE OF REPORT & PERIOD COVERED Final

⑥ National Dam Safety Program  
Broadus Dam (Inventory Number VA03917)  
York River Basin, Caroline County,  
Commonwealth of Virginia  
Phase I Inspection Program

Name of Dam: Broaddus Dam  
State: Commonwealth of Virginia  
County: Caroline  
USGS 7.5 Minute Quadrangle: Bowling Green, Virginia  
Stream: Maracossic Creek  
Date of Inspection: 8 July 1980

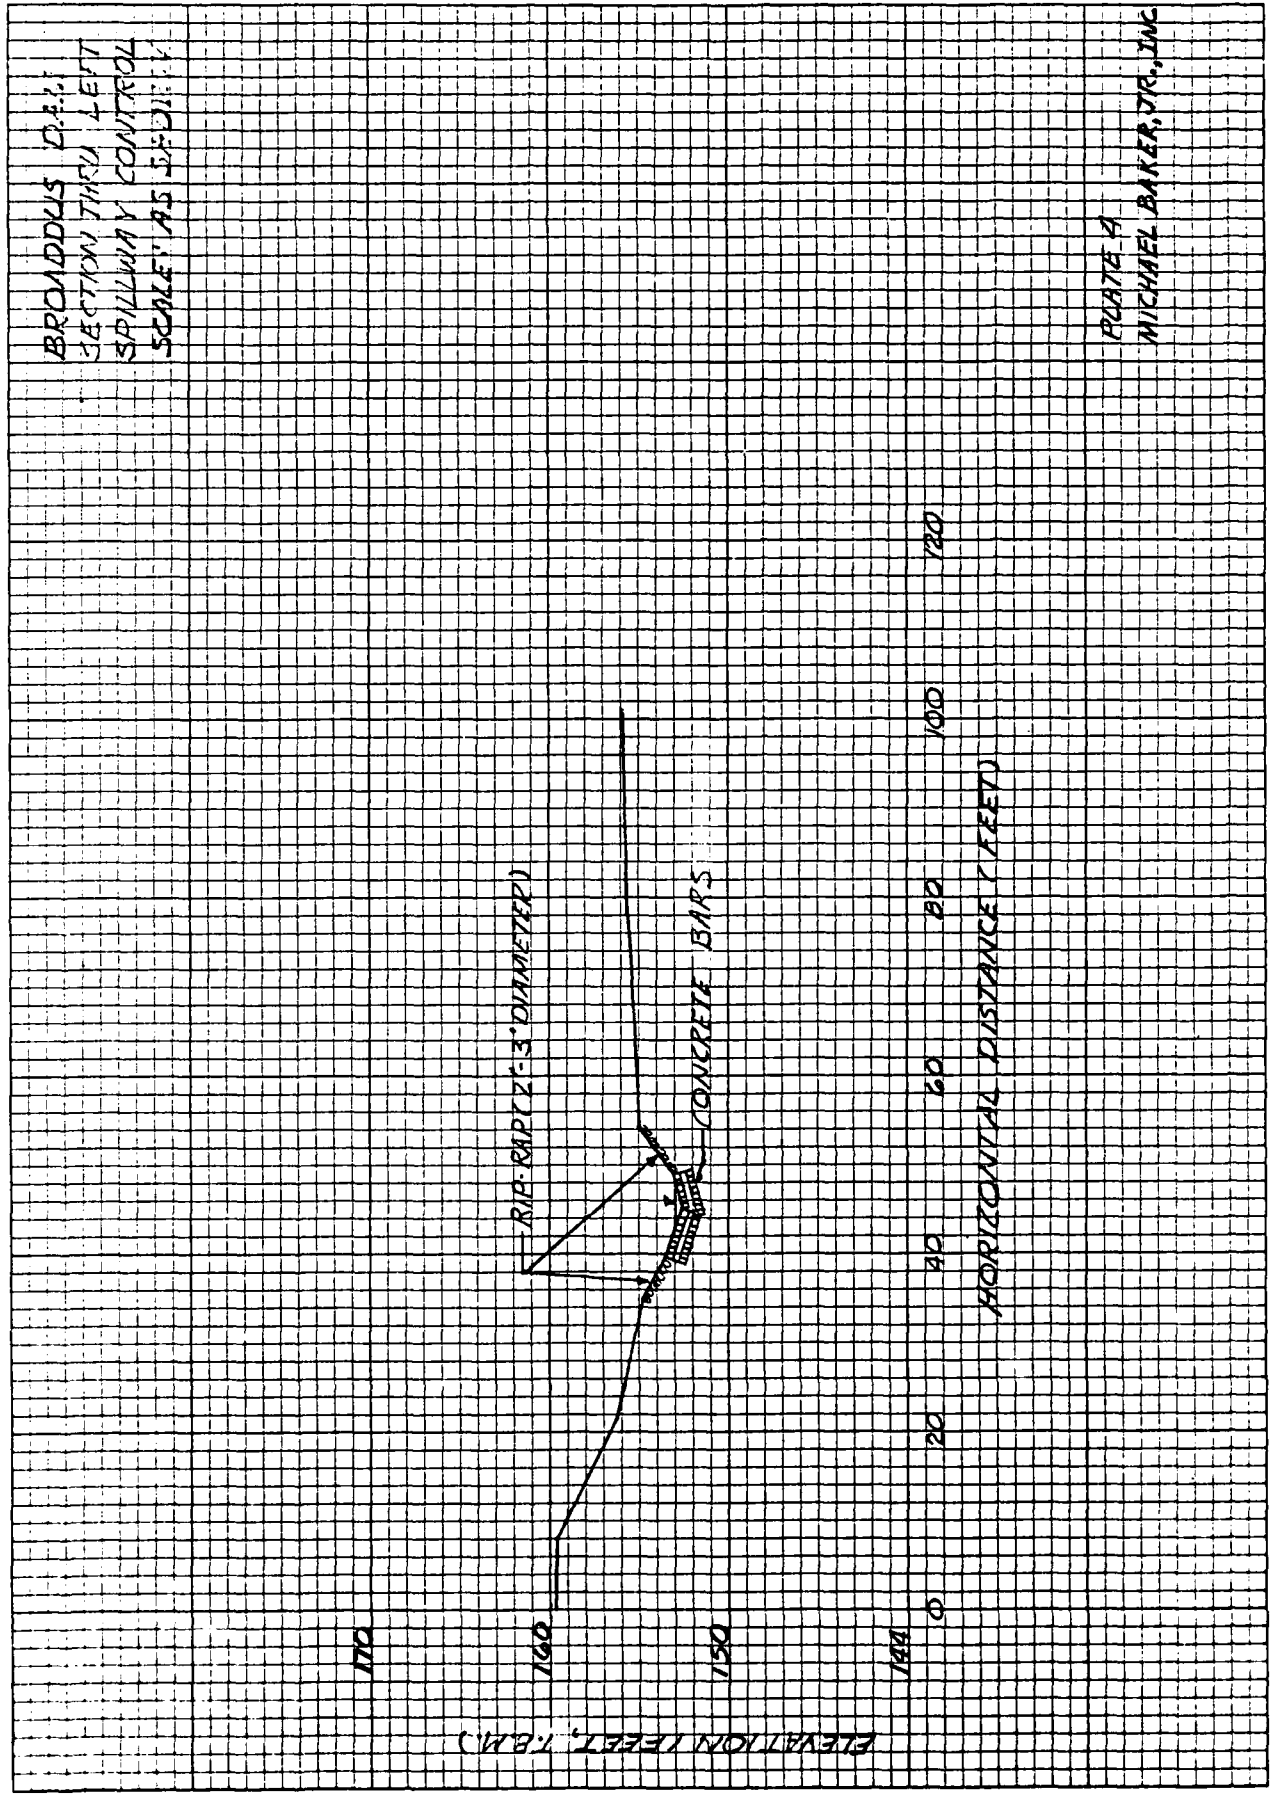
PLATE 4  
MICHAEL BAKER, JR., INC.

BROADBENT D.E.  
SECTION THRU LEFT  
SPILLWAY CONTROL  
SCALE: AS SHOWN
